CONNECTICUT RIVER BASIN
WESTBROOK, CONNECTICUT

**MESSERSCHMIDT POND DAM
CT 00392**

**PHASE I INSPECTION REPORT
NATIONAL DAM INSPECTION PROGRAM**

NOVEMBER, 1979

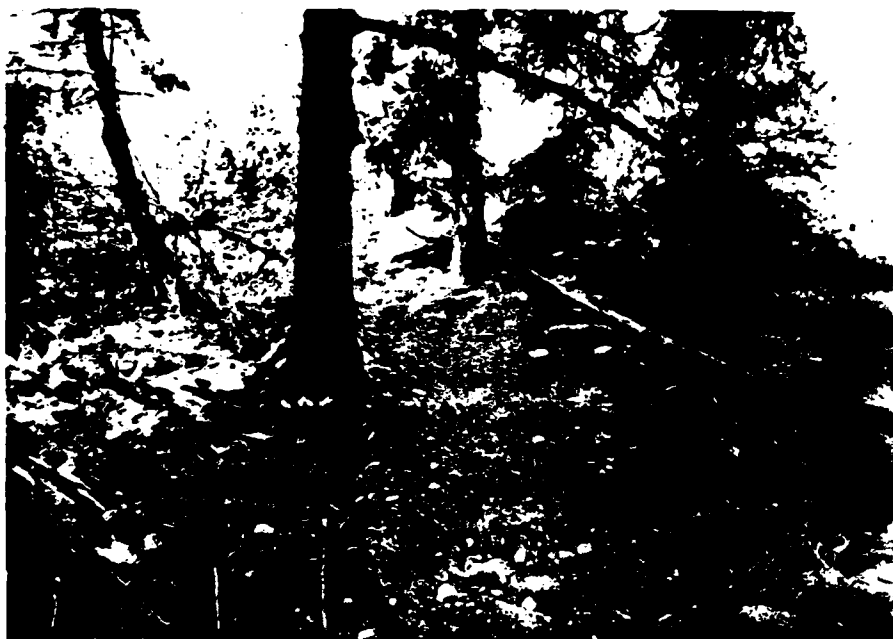
The downstream slope of all the embankments is very overgrown, including large trees of 12 inches and more in diameter (Photos 3 and 4). Erosion, probably caused by trespassing, was noted at the center and left side of the downstream slope of the central embankment (Photo 3). The concrete retaining wall at the left embankment had numerous deteriorations including spalling, exposed aggregate, and wide cracks up to 1 inch in width (Photo 5).

Photo 3 - Erosion on downstream slope of central embankment near principal spillway (Sept 1979)
